Cost-effective approach to reducing collisions with elk by fencing between existing highway structures

Abstract: Collisions with large ungulates cause serious human and animal injuries and significant property damage. Therefore, wildlife crossing structures are increasingly included in new road construction to reduce wildlife–vehicle collisions, while still allowing wildlife to safely cross roads. Recently, state and federal transportation budgets have declined, concomitantly reducing the construction of wildlife crossing structures, which are generally tied to large-scale reconstruction projects that are delayed for decades into the future. Nevertheless, even during times of fiscal constraint or temporal delay, it is still necessary to reduce collisions with wildlife and maintain habitat connectivity. Therefore, it is important to find cost-effective and functional alternatives. Retrofitting roadways with wildlife exclusion fencing that directs animals to existing highway structures (e.g., sufficiently sized bridges and culverts) is a possible cost-effective, interim solution that needs further testing. Along Interstate-17 in northern Arizona, we heightened 9.17 km of right-of-wa

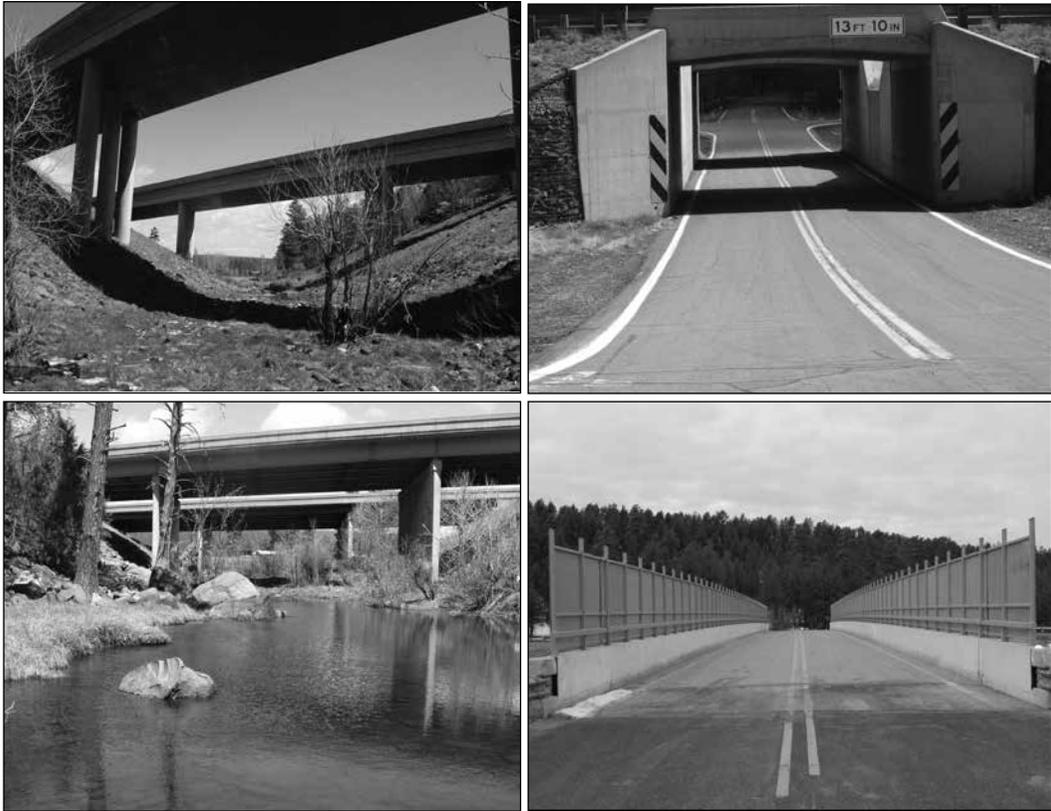
Figure 2. Four existing structures that were connected by 9.17 km of 2.4-m-high elk retrofit exclusion fencing along Interstate-17 in northern Arizona, USA (completed in February 2012). Clockwise from top left: Munds Canyon Bridge, Schnebly Hill Traffic Interchange, Fox Ranch Traffic Interchange, and Woods Canyon Bridge.

Arizona Department of Transportation worked with Arizona Game and Fish Department to gather elk movement and wildlife–vehicle collision data to incorporate wildlife crossing structures into the reconstruction plans for a 77-km stretch of I-17 (Gagnon et al. 2013). They identified 19 potential wildlife crossing structure locations for inclusion in highway reconstruction plans. Proposed wildlife crossing structures would be connected with 2.4-m-high, woven-wire fence to funnel animals to the wildlife crossing structures. However, the reconstruction was delayed, hence the need to find alternatives. Therefore, the 2 agencies focused on a 9.17-km segment that had a high incidence of elk–vehicle collision (20.3 per year, 2007 to 2010) and 4 structures with the potential to function as wildlife crossing structures (Figure 2; Table 1).
